From: Commander, Naval Special Warfare Command
To: Commander, Naval Special Warfare Development Group
Subj: COMMAND INVESTIGATION INTO THE CIRCUMSTANCES SURROUNDING
THE DEATH OF SOCS THOMAS VALENTINE, USN, ON OR ABOUT
13 FEB 08 IN MARANA, ARIZONA

Subj: COMMAND INVESTIGATION INTO THE CIRCUMSTANCES SURROUNDING
THE DEATH OF SOCS THOMAS VALENTINE, USN, ON OR ABOUT
13 FEB 08 IN MARANA, ARIZONA

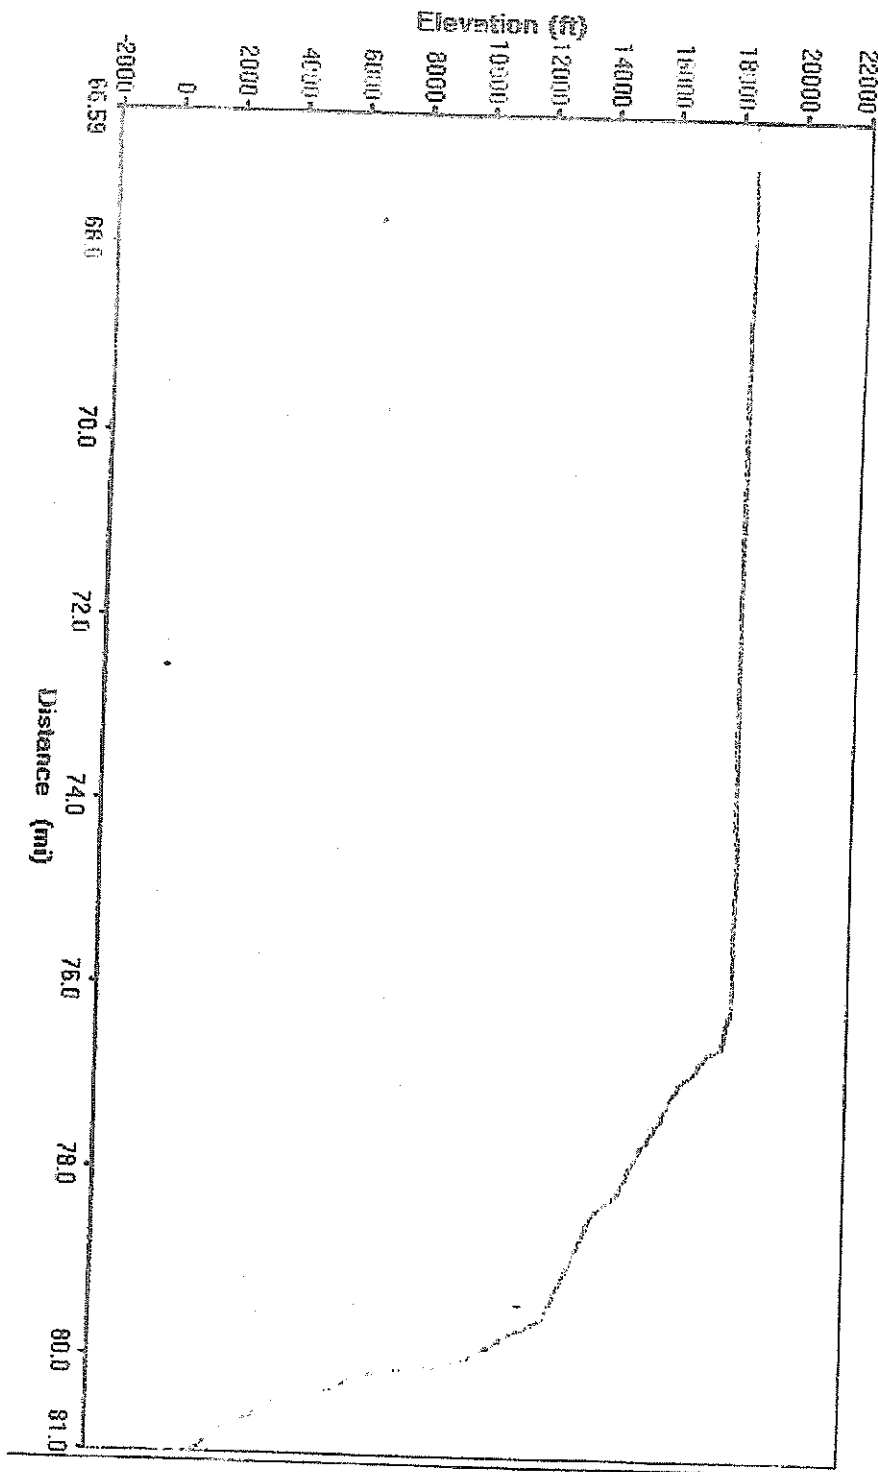
8 of 11

Valentine's profile: note start of jump

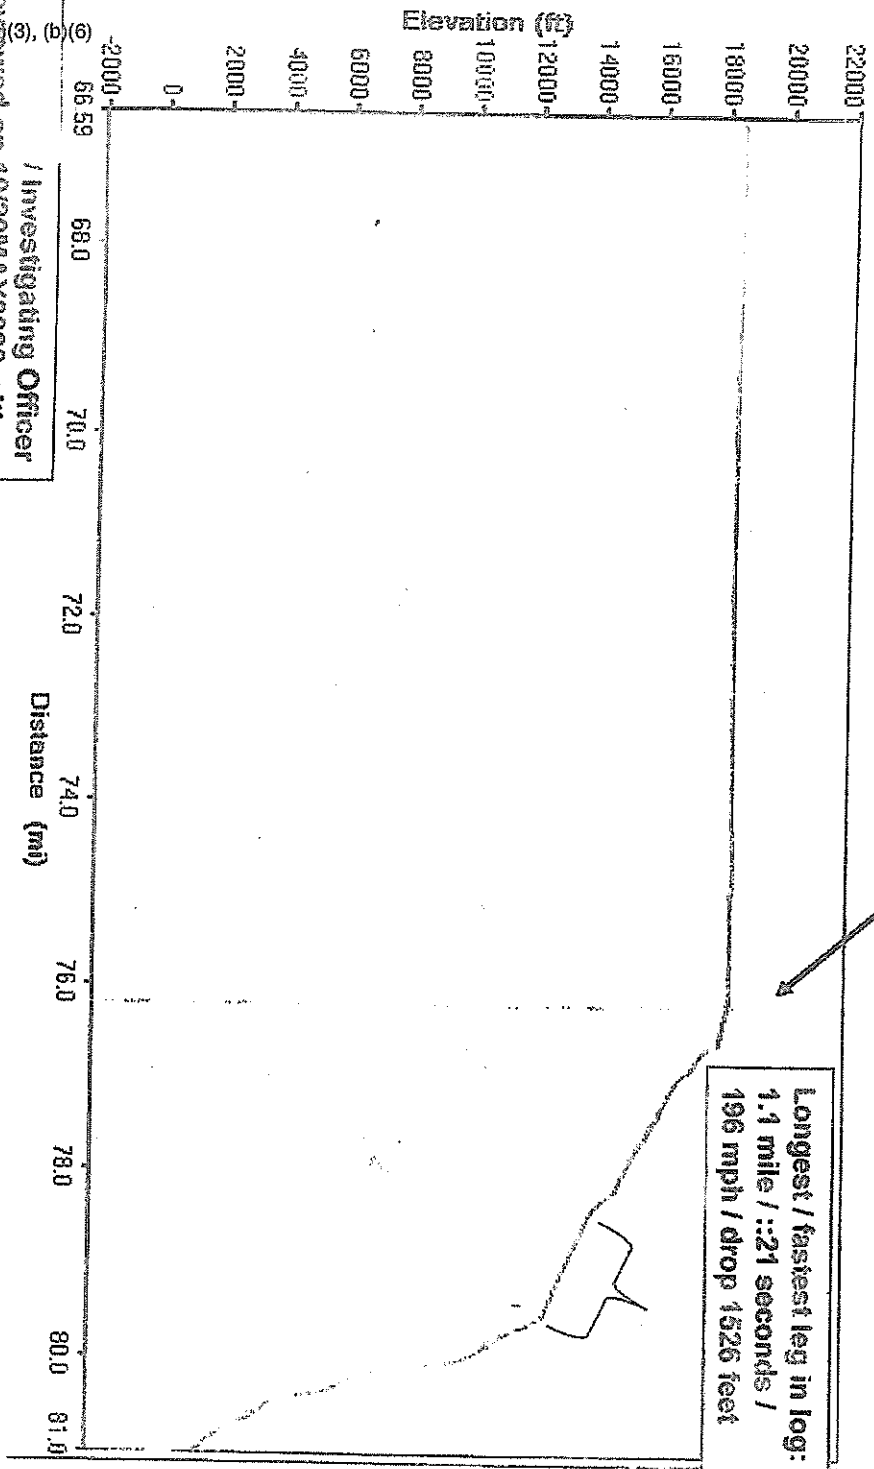
Longest / fastest leg in log:
1.1 mile / ::21 seconds /
196 mph / drop 1526 feet

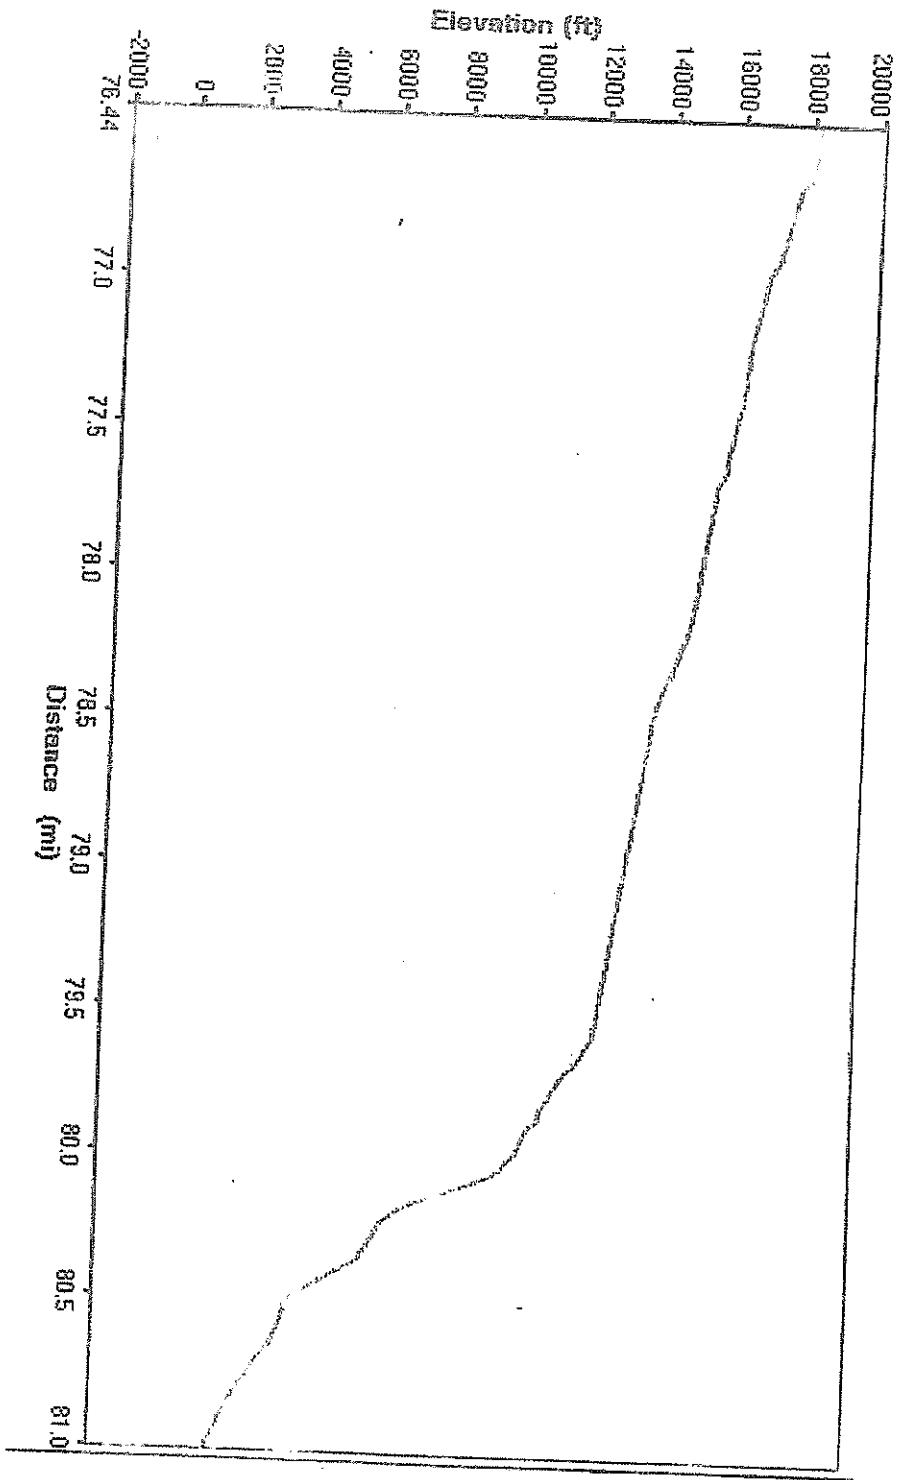
10 of 11

HAWO member profile: note start of jump
